Navigation for the Derbyshire Phase2 Survey

S. Lerner
D. Yoerger
T. Crook

May 1999

WHOI-99-11

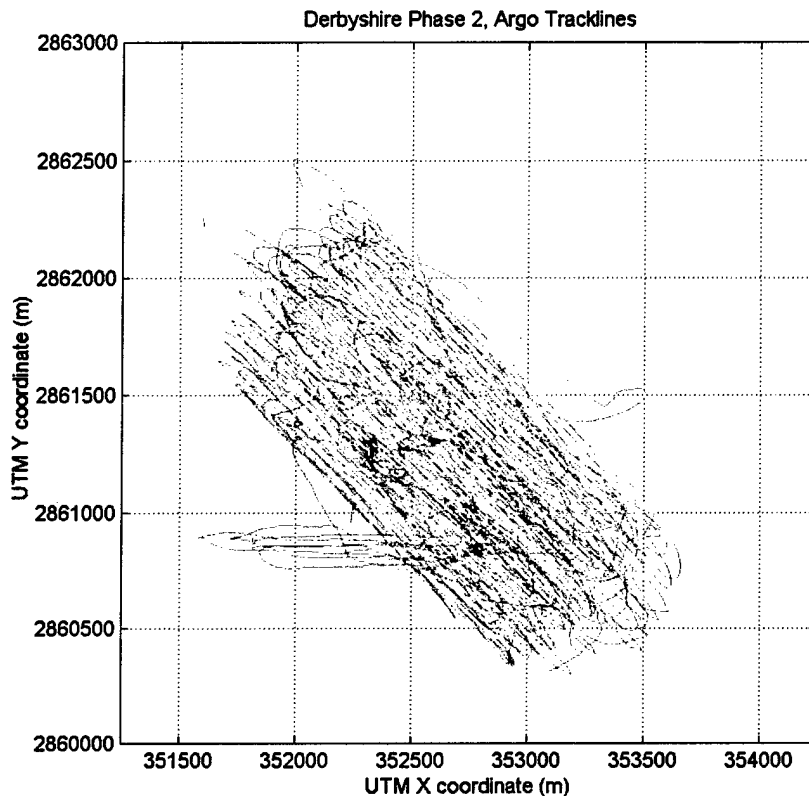
Figure 6: Complete set of Argo tracklines

Our goal was to obtain complete photographic coverage of the entire wreck site. As we control Argo primarily by maneuvering the vessel, this represented a challenge in over 4000 meters of water. In particular, the sluggish response of the vehicle to vessel movements makes the task difficult. Figure 6 shows the complete set of Argo tracklines.

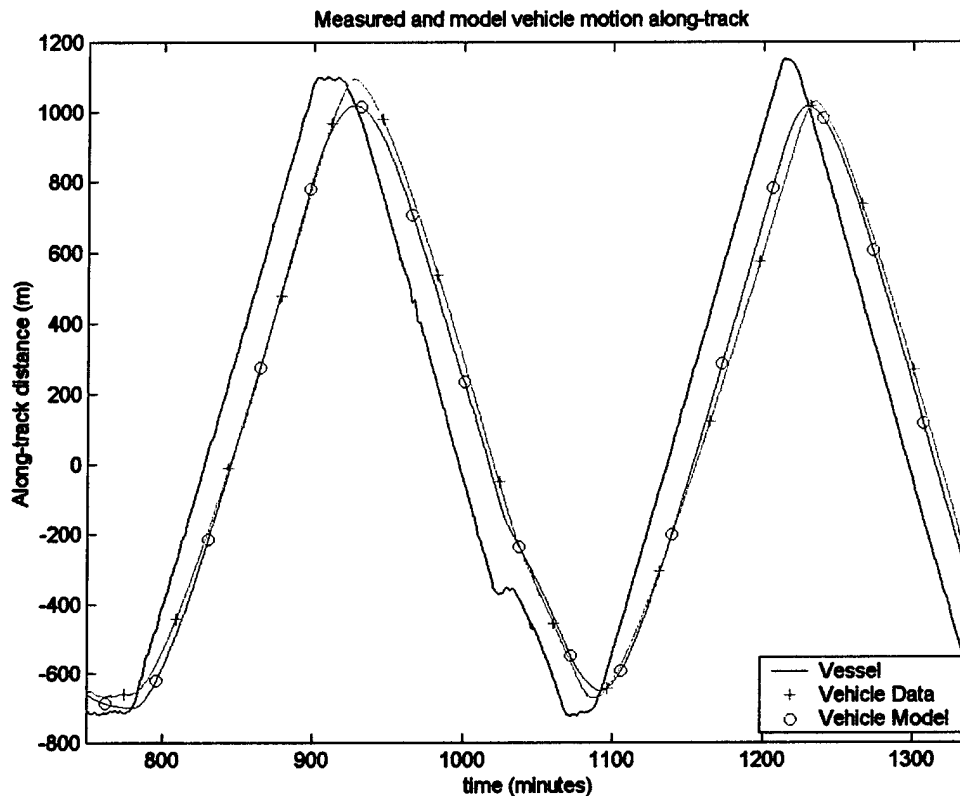
Figure 7 Modelled versus measured vehicle response along track. This plot shows distance traveled by the ship, vehicle, and a model. The model is a simple first-order system with a time constant of 18 minutes.

Figure 7 shows the dynamic response of the vehicle to vessel motion along with the response of a simple first-order model. Both vessel and vehicle movements have been transformed into a plane oriented along the nominal trackline direction. While the model is naïve in several ways (it ignores currents, depth changes, hydrodynamic nonlinearities, and out-of-plane motion), it clearly captures much of the relevant dynamics. It performs worst in turns, where the vessel motion is most extreme, velocity changes and out-of-plane motion are the large.

By fitting the model to the vehicle response, we can determine the time constant of the primary vehicle dynamic response to one-dimensional vessel motion. In the model shown in figure 7, the time constant was set to 18 minutes.

From our assumption of a linear first-order dynamic and the time constant, we can also compute the steady-state distance between vessel and vehicle (layback) as a function of vessel speed. A time constant of 18 minutes corresponds to a layback of 1080 meters. We expect that the layback will be dependent on speed in a nonlinear fashion, so these results are most valid around our operating speed during this survey, 0.5 knots = .25 m/second.

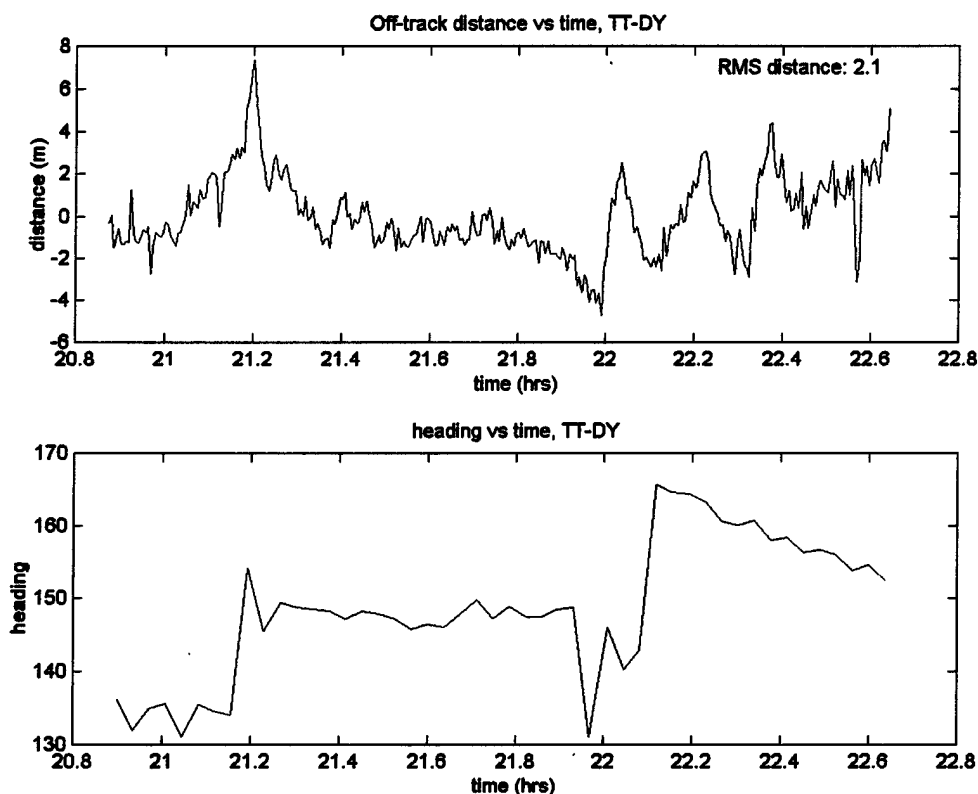
Figure 9. This plot shows trackline error and vehicle heading. As the track error grows just prior to 22 hours, a heading change is applied.

Figure 9 shows vehicle off-track error versus time along with the vehicle heading. The errors are quite low, $\text{rms} = 2.1$ meters. Just before 22 hours, the vehicle trackline error starts to grow, and a heading was commanded to change in order to counter the error. This heading change (probably along with side thrust),

brought the vehicle back on line.

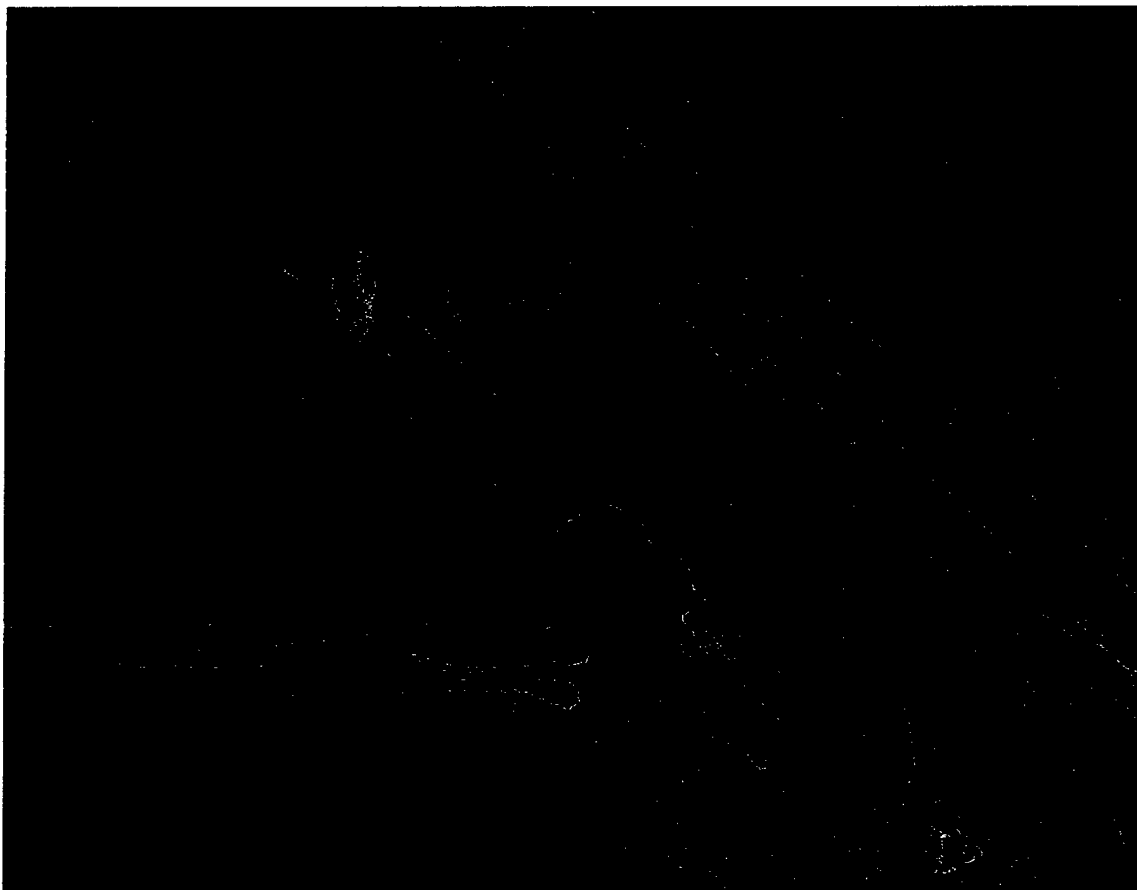
Figure 10. This plot shows the crossing line used to determine navigation repeatability.

Figure 10 shows the tie line superimposed on the survey tracks. The line cuts across 41 tracklines, and the imagery for most crossings has sufficient features to provide a good match.
